**TEARDOWN REPORT  
OF TWO MODEL TPE331-10T-515K TURBOPROP ENGINES  
SERIAL NUMBER P-79297C AND P-79001C**

**October 8, 2014**

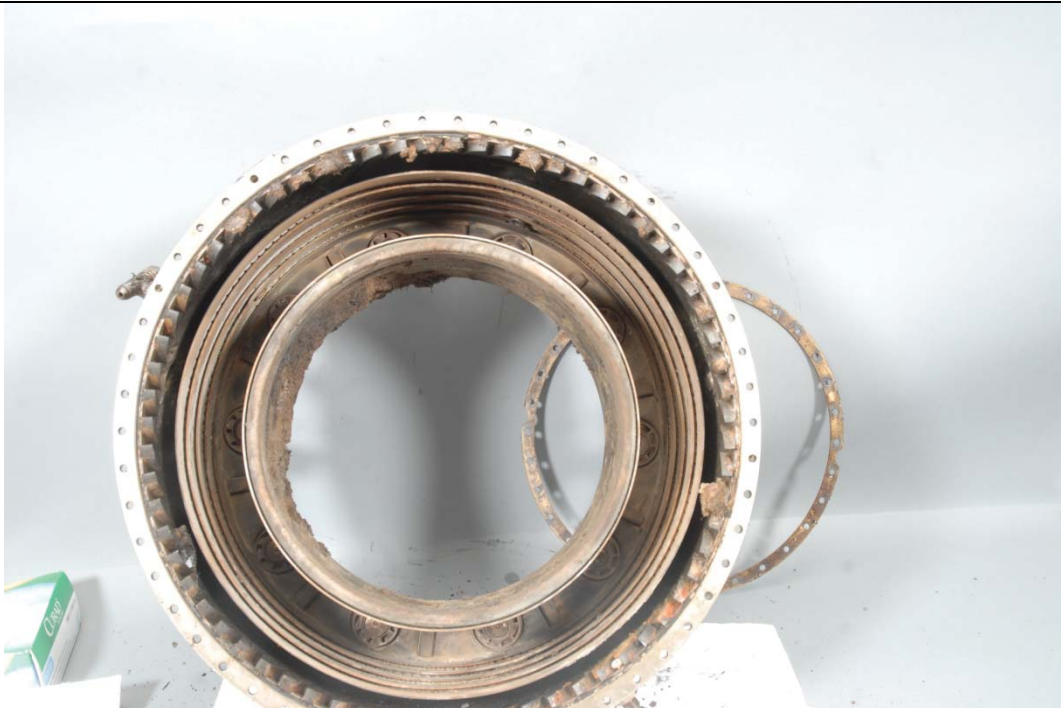
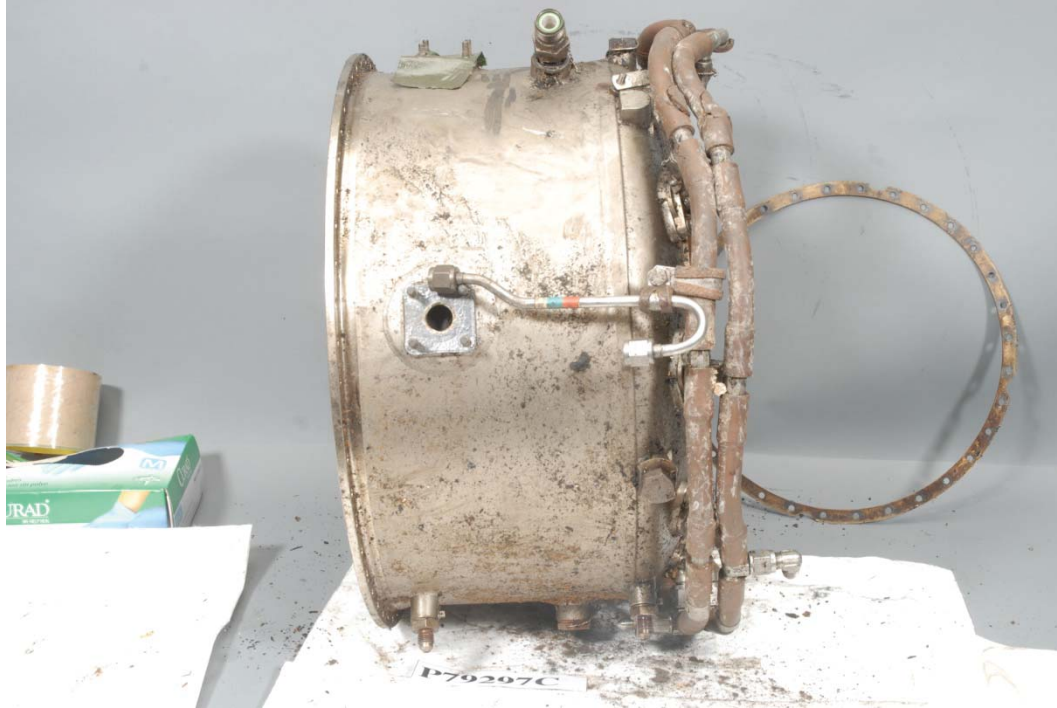
**Figure 119. P-79297C, Combustor Section Assembly, ALF**

- (b) Combustor Plenum Case: (Figure 119 and Figure 120)
- There was earthen debris adhering to the external surface of the combustor plenum case. (Figure 121)

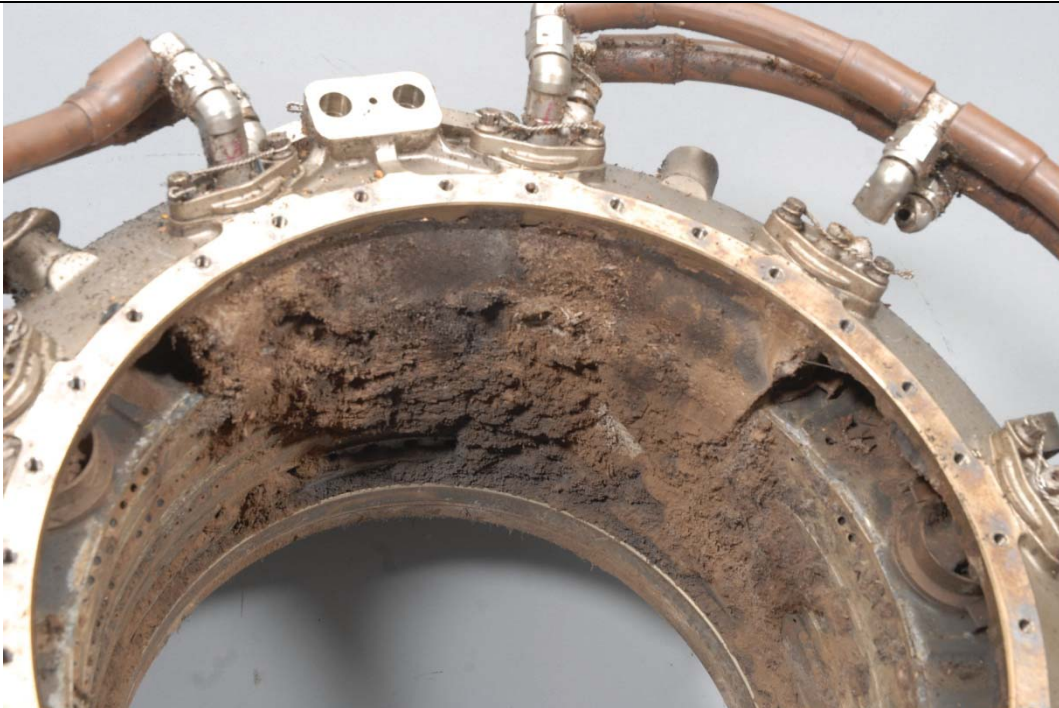
**Figure 123.** P-79297C, De-swirl Vane Assembly, Foreign Object Debris

- The de-swirl vane assembly had earthen debris adhering to the leading edges of many of the vanes. (Figure 123)
- (d) Combustion Chamber:
- The combustion chamber was intact

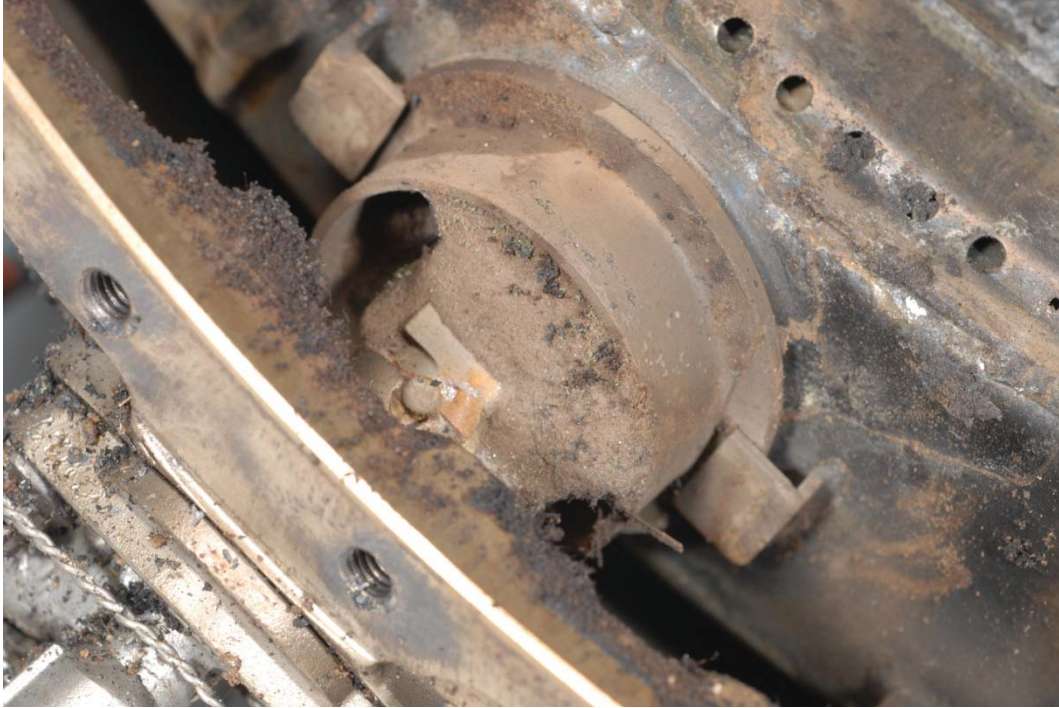
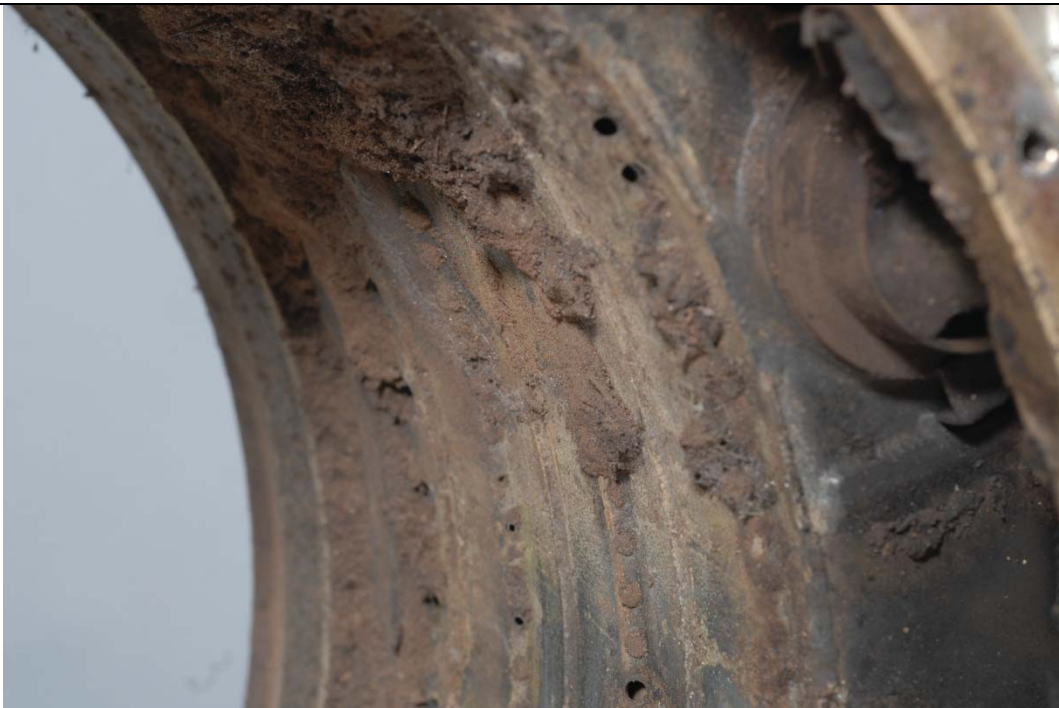
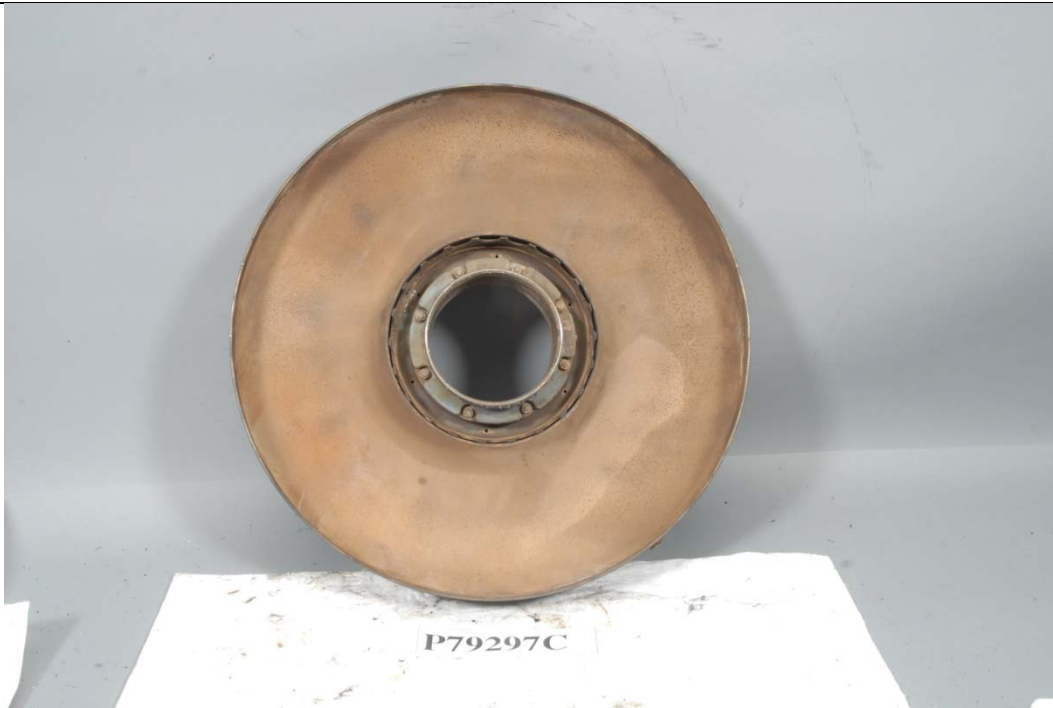
- The combustion chamber contained earthen debris in and around various cooling holes, fuel nozzle swirlers, inner diameter seams and skirts of the combustor. (Figure 124, Figure 125, Figure 126)

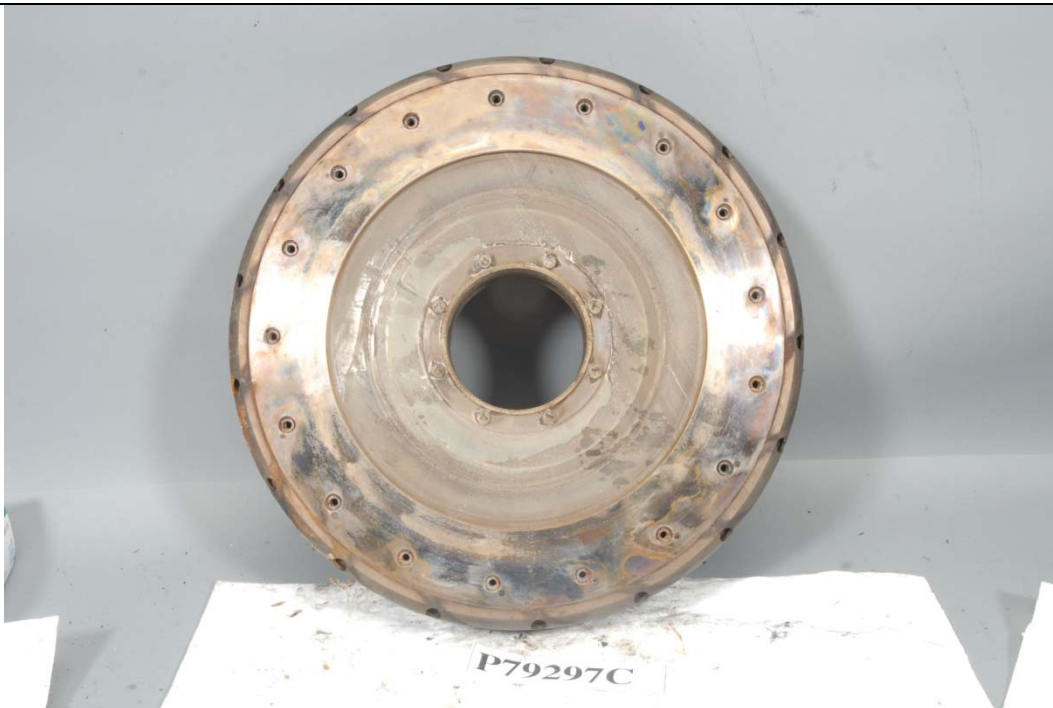
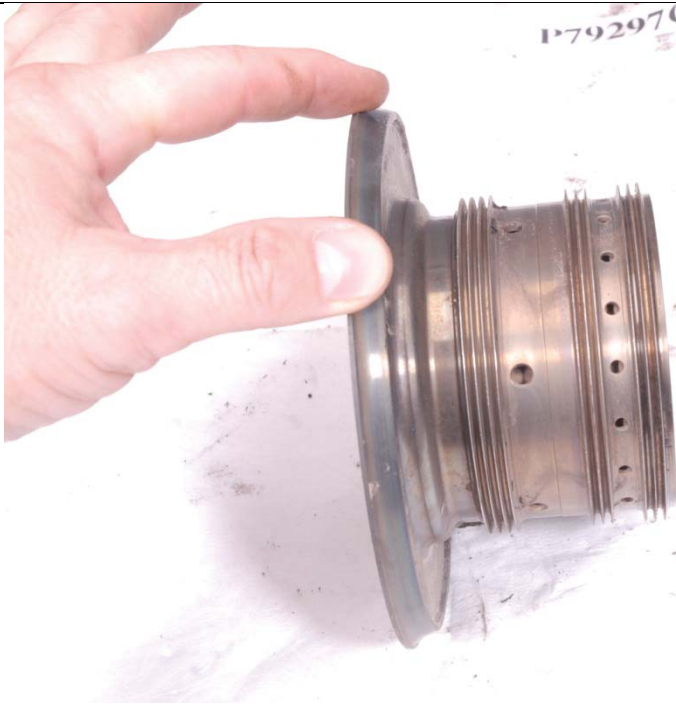
**Figure 127.** P-79297C, Outer Transition Liner, ALF

- The combustion chamber was not removed from the plenum for detailed inspection.
- (e) Outer Transition Liner: (Figure 127 and Figure 128)
- The outer transition liner was intact.

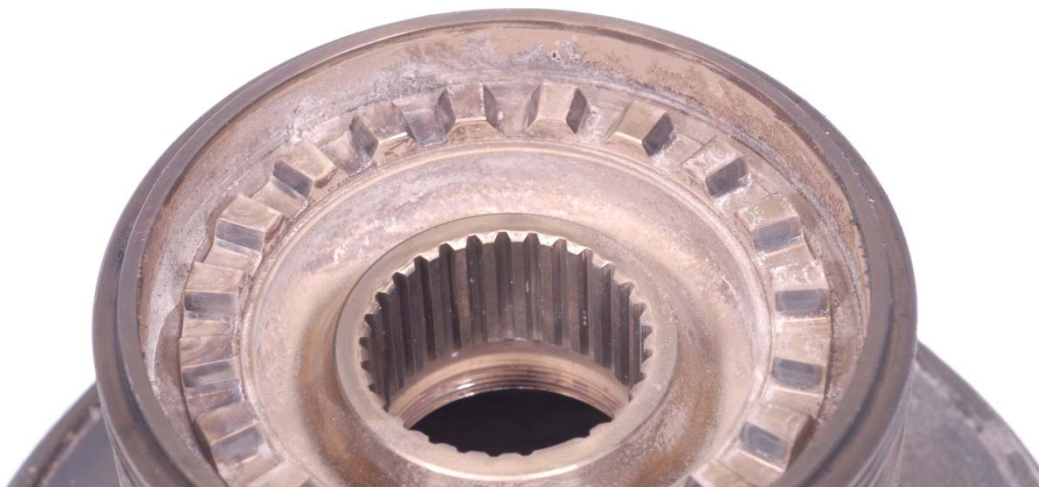
**Figure 129.** P-79297C, Center Curvic Coupling

- (a) Center Curvic Coupling: (Figure 129)
- The center curvic coupling was intact.
  - The center curvic forward coupling teeth appeared to be undamaged. (Figure 130)
  - The center curvic aft coupling teeth appeared to be undamaged. (Figure 131)
- (b) First-Stage Turbine Stator Assembly: (Figure 132 and Figure 133)
- The first-stage turbine stator assembly was not disassembled from the vane case.
  - There was dirt adhering to all of the vane surfaces of the first-stage turbine stator. (Figure 134)

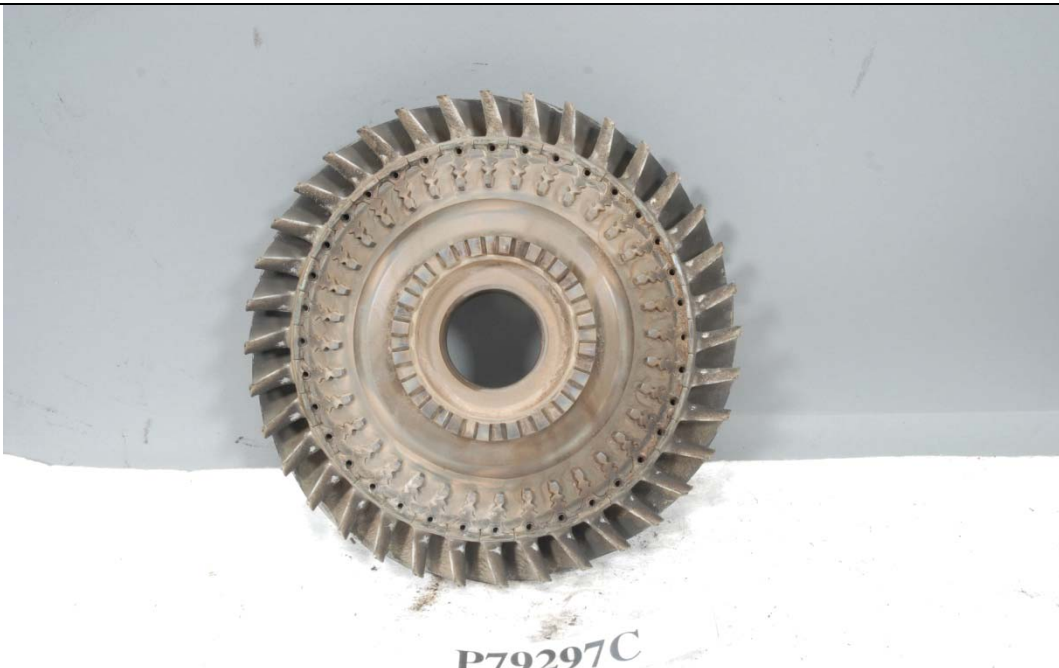
**Figure 137.** P-79297C, First-Stage Turbine Stator Assembly, Rotational Scoring on First-Stage Turbine Shroud

- The first-stage turbine stator displayed rotational scoring through approximately 90 degrees of the shroud surface. (Figure 137)
- (c) First-Stage Turbine Rotor: (Figure 138 and Figure 139)

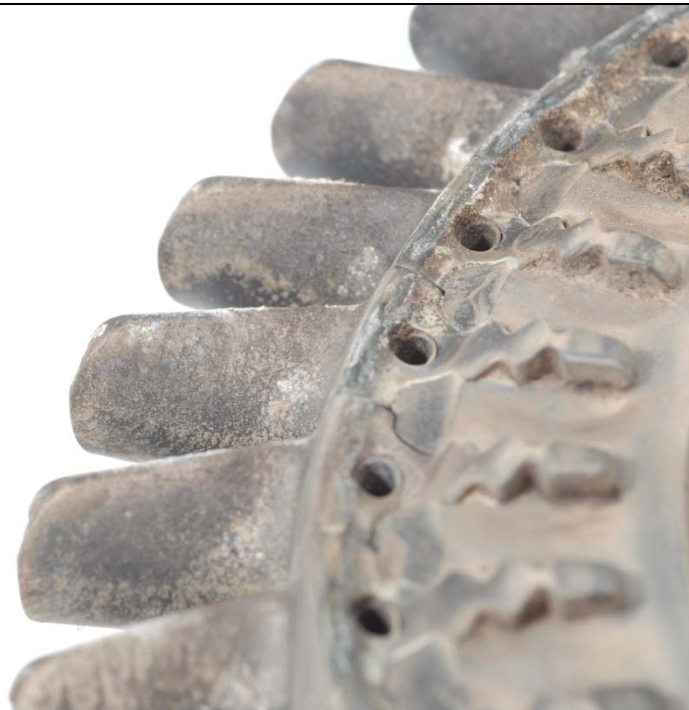
**Figure 141.** P-79297C, First-Stage Turbine Rotor

- There were rotational score marks at the leading edge tip of all the first-stage rotor turbine blades. (Figure 141)
  - There was earthen debris on the suction side of the first-stage turbine rotor blades. (Figure 142)

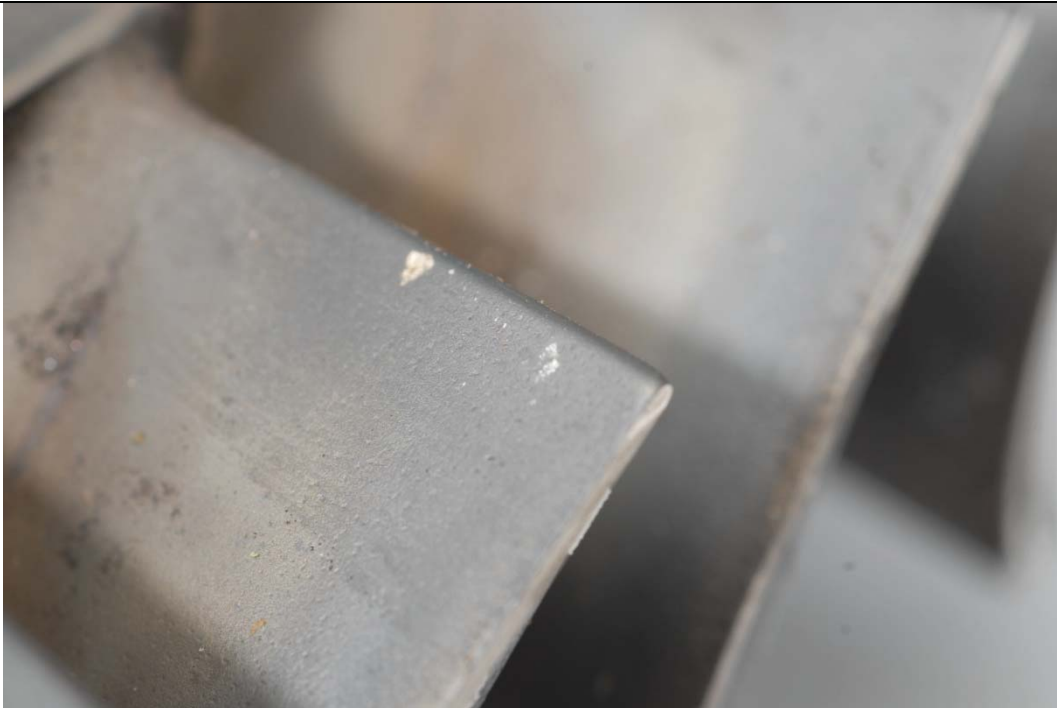
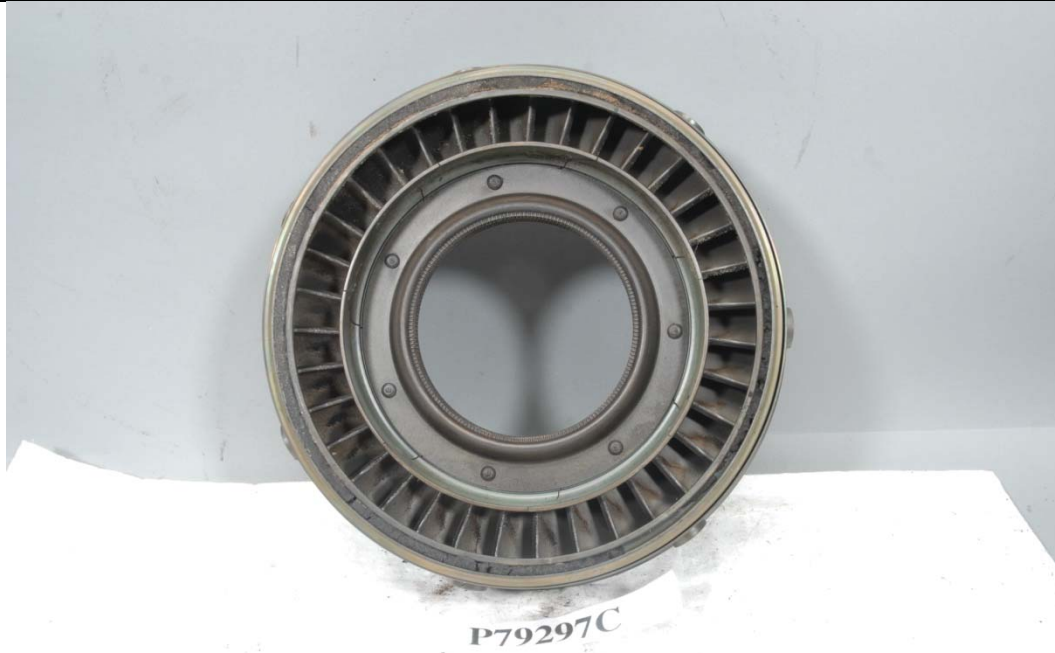
- The first-stage turbine rotor forward and aft curvic teeth appeared to be undamaged.
  - After cleaning, the first-stage turbine rotor displayed metal spray deposits on the suction side turbine blades. (Figure 143 and Figure 144)

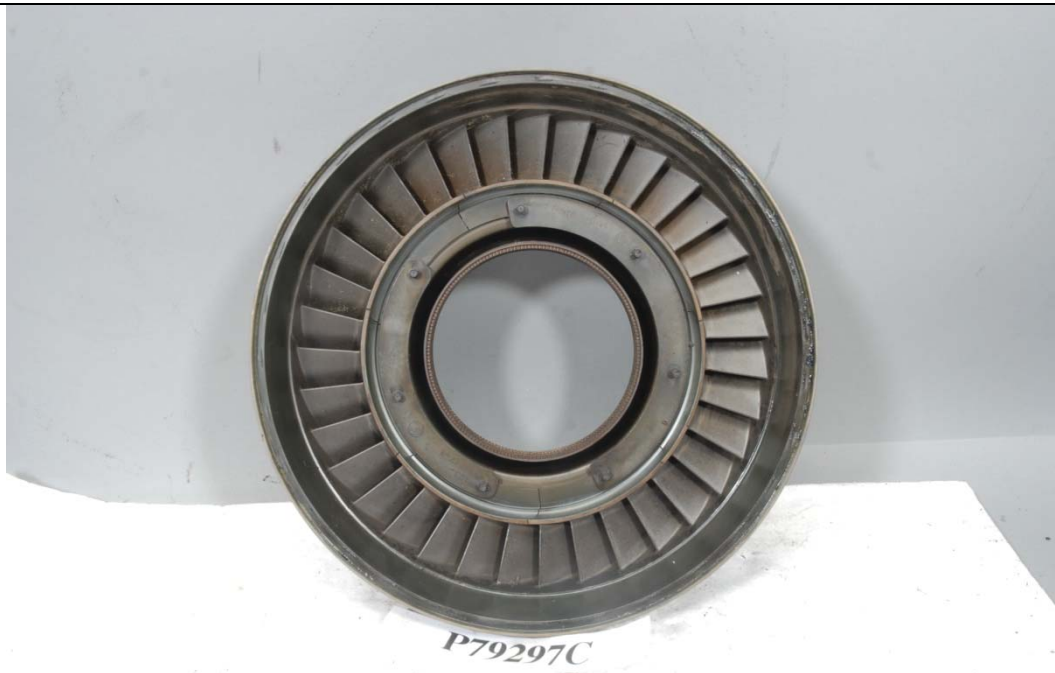
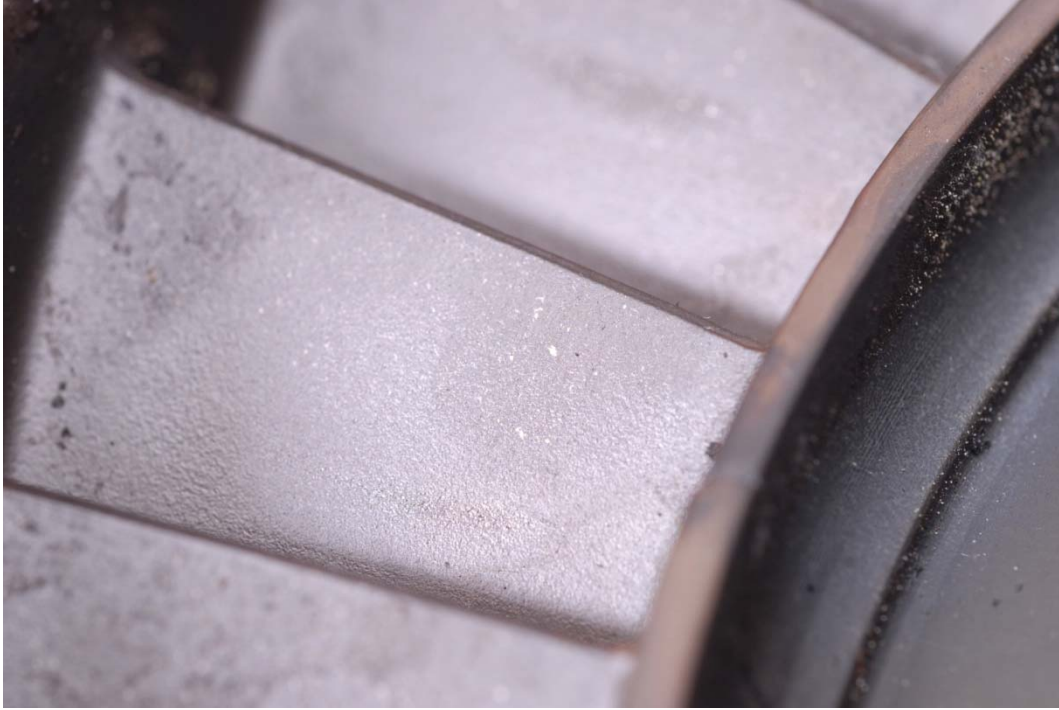
- (d) Second-Stage Turbine Stator: (Figure 145 and Figure 146)
- The second-stage turbine stator was intact.
  - After cleaning, the second-stage turbine stator displayed metal spray deposits on the suction side of the stator vanes. (Figure 147)

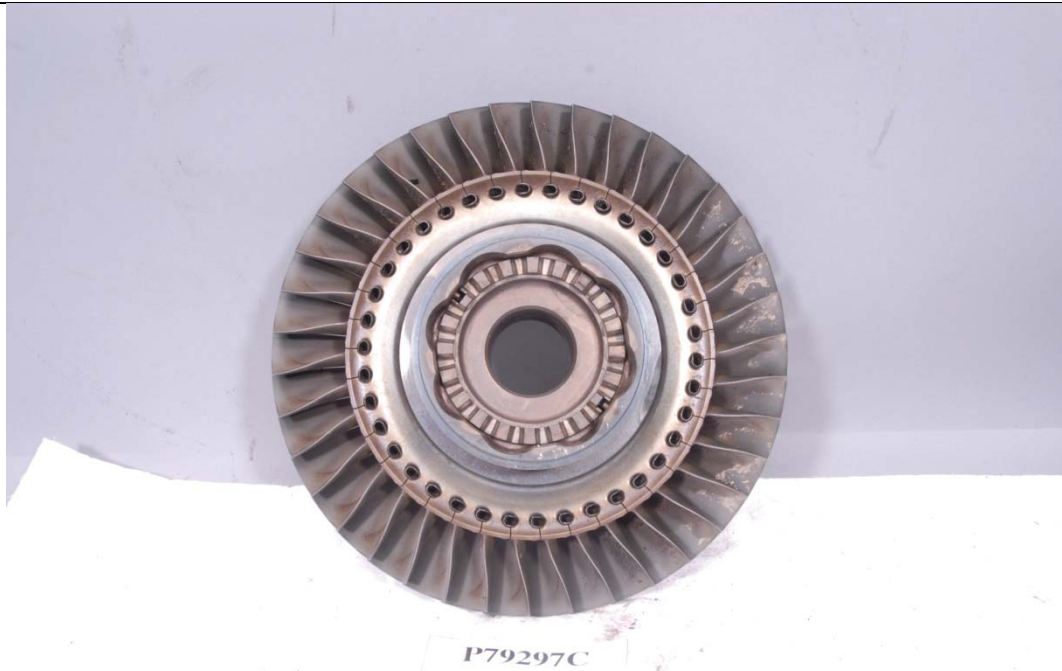
**Figure 148. P-79297C, Second-Stage Turbine Stator, Rotational Scoring**

- The second-stage turbine stator displayed rotational scoring through approximately 90 degrees of the shroud surface (Figure 148) with corresponding scoring to the shroud line edge of all second-stage turbine blades.

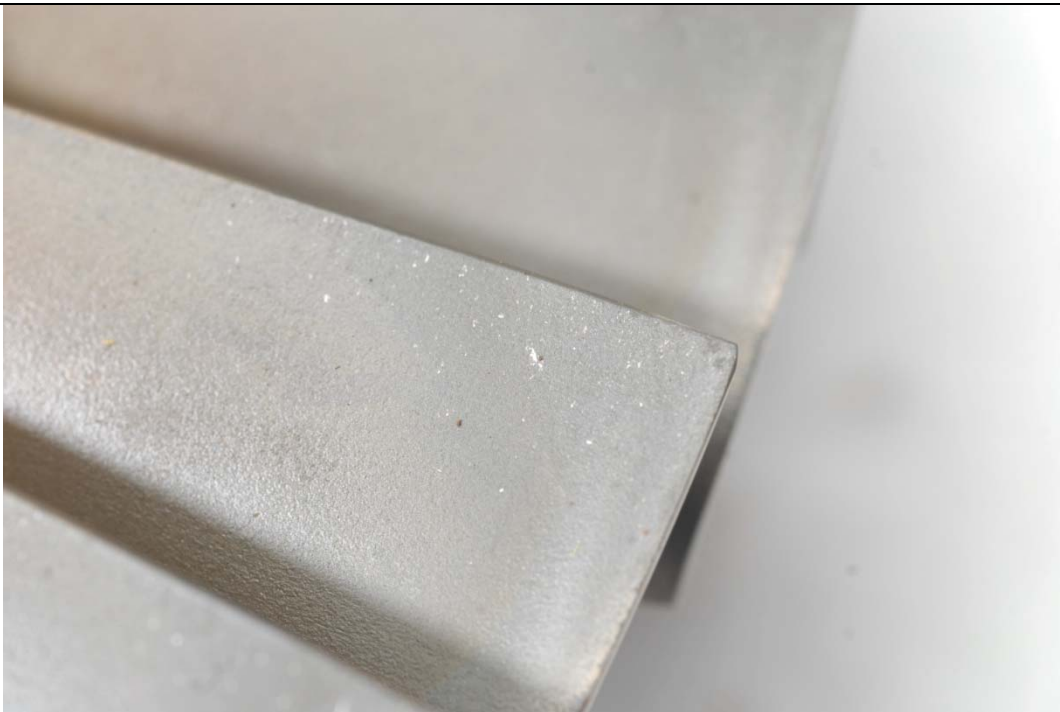
**Figure 151.** P-79297C, Second-Stage Turbine Rotor

- (e) Second-Stage Turbine Rotor: (Figure 149 and Figure 150)
- Part Number: 3102106-10
  - Serial Number: 98013-4516790
  - Lot Number: 99-P036
  - The second-stage turbine rotor displayed rotational scoring on the shroud line edge of all blade tips (Figure 151) with corresponding rotational scoring on the second-stage turbine blade tip shroud.

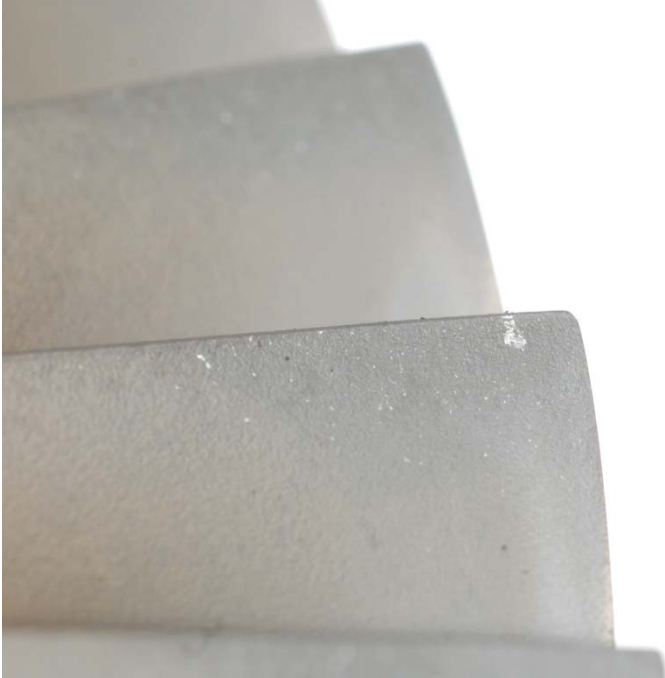
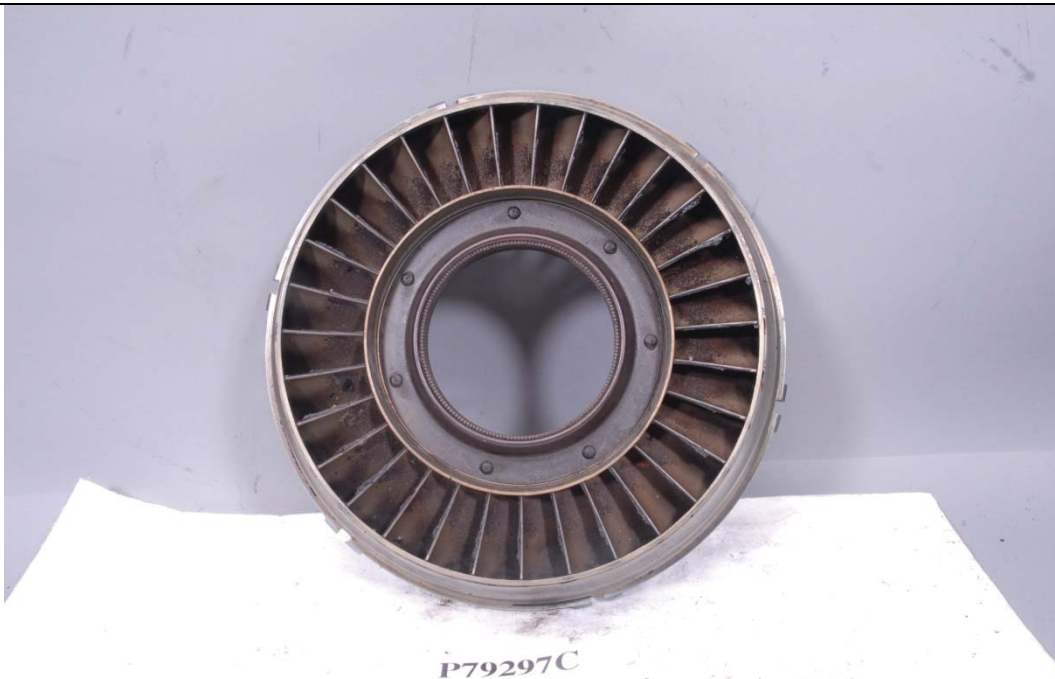
- There were compressor-shroud metal spray deposits on the suction side of the second-stage turbine rotor blades. (Figure 152 and Figure 153)
  - The second-stage turbine rotor forward and aft curvic teeth appeared to be undamaged.

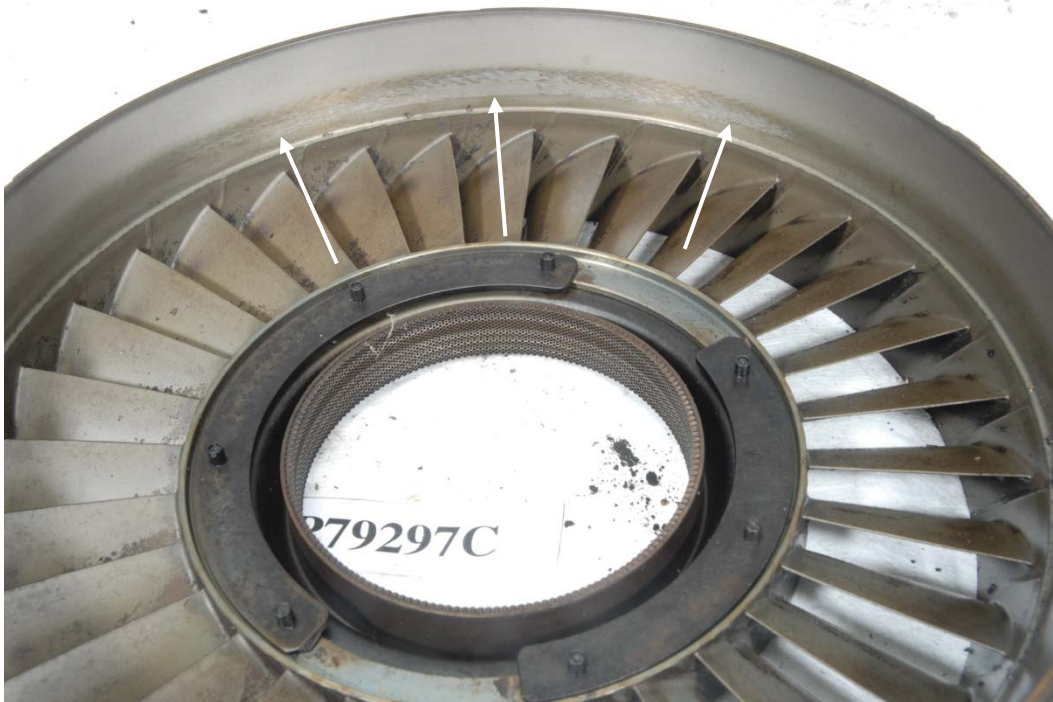
**Figure 156.** P-79297C, Third-Stage Turbine Stator, FLA

- (f) Third-Stage Turbine Stator: (Figure 154, and Figure 155)
- The third-stage turbine stator was intact.
  - There was dirt adhering to both the pressure leading edge surfaces of the third-stage turbine stator vanes. (Figure 156)

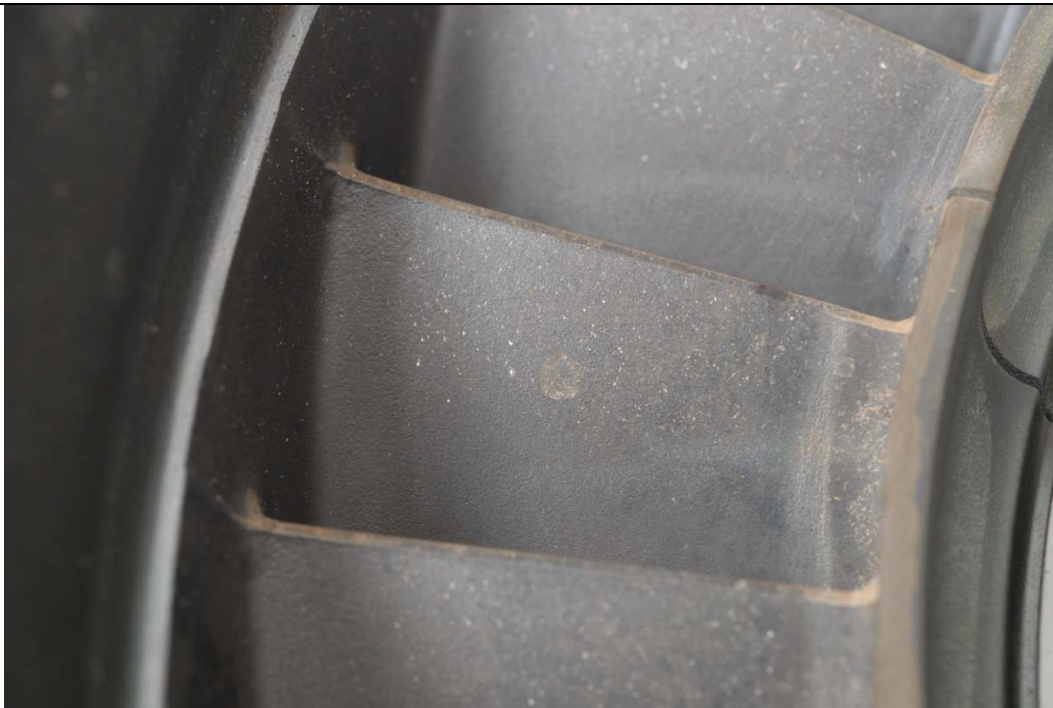
**Figure 157.** P-79297C, Third-Stage Turbine Stator, Rotational Scoring

- The third-stage turbine blade tip shroud displayed rotational scoring through 90 degrees (Figure 157) with corresponding scoring on the shroud line edge of the third-stage turbine rotor blades.

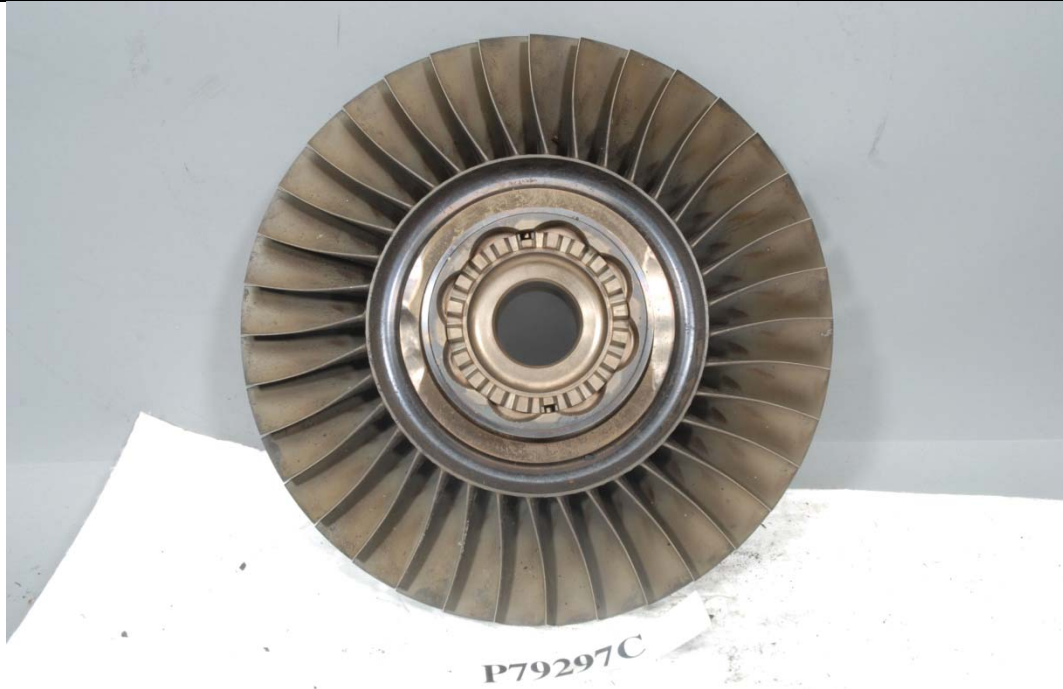
**Figure 158.** P-79297C, Third-Stage Turbine Stator, Metal Spray Deposits

- After cleaning, the third-stage turbine stator displayed metal-spray deposits on the suction side of the third-stage turbine stator vanes. (Figure 158)

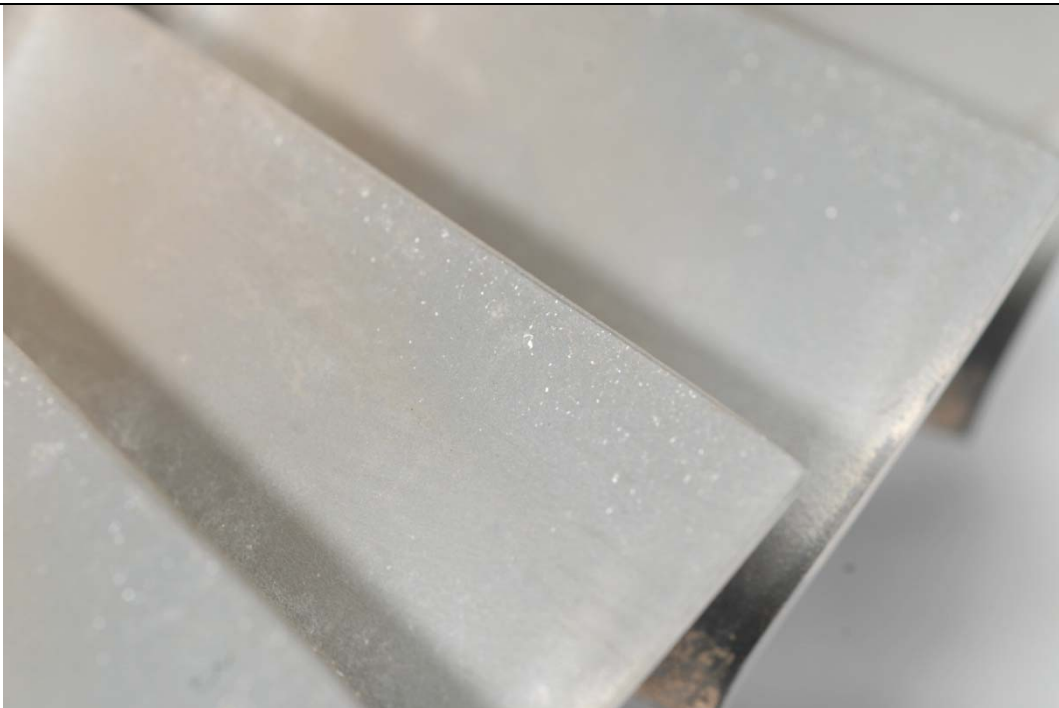
**Figure 161. P-79297C, Third-Stage Turbine Rotor**

- The third-stage turbine rotor displayed rotational scoring on the shroud line edge of all blade tips (Figure 161) with corresponding rotational scoring on the third-stage turbine blade tip shroud.

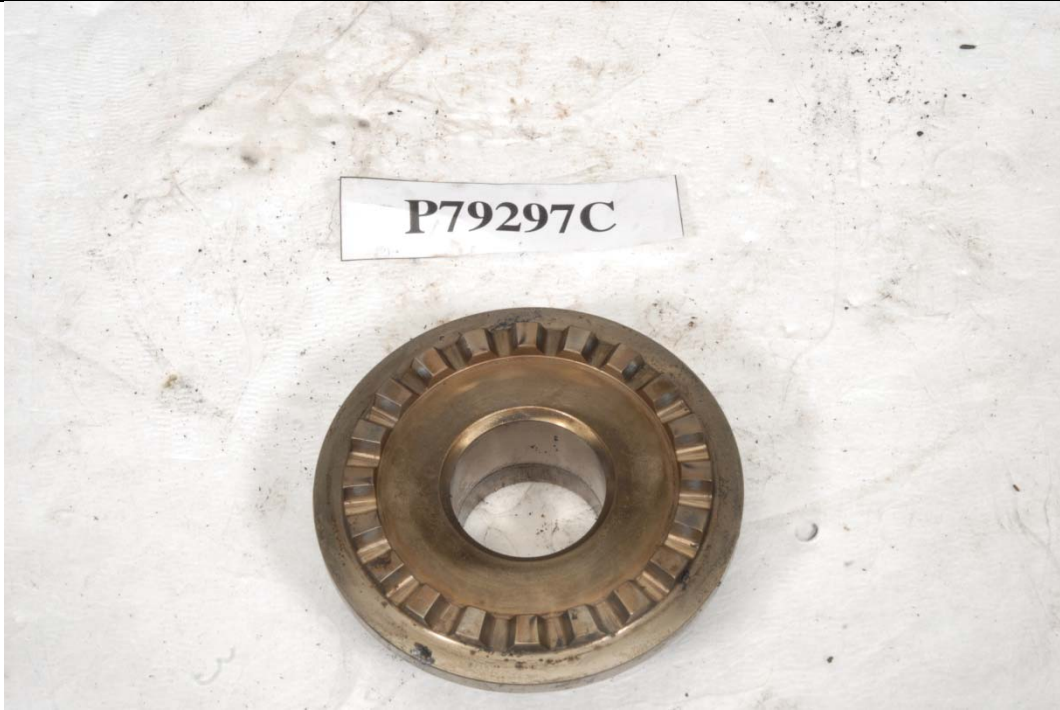
**Figure 162. P-79297C, Third-Stage Turbine Rotor, Metal Spray Deposits**

- After cleaning, the third-stage rotor displayed compressor-shroud metal-spray deposits on the suction side of the turbine blades. (Figure 162)
  - The forward and aft curvic teeth of the third-stage turbine rotor appeared to be undamaged.

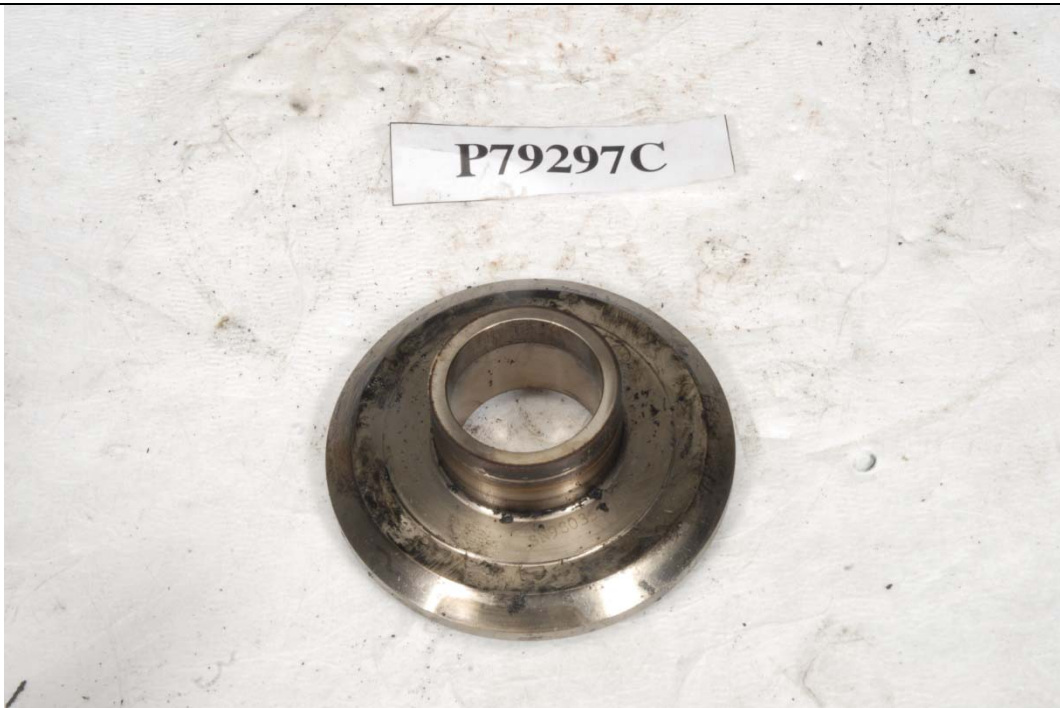
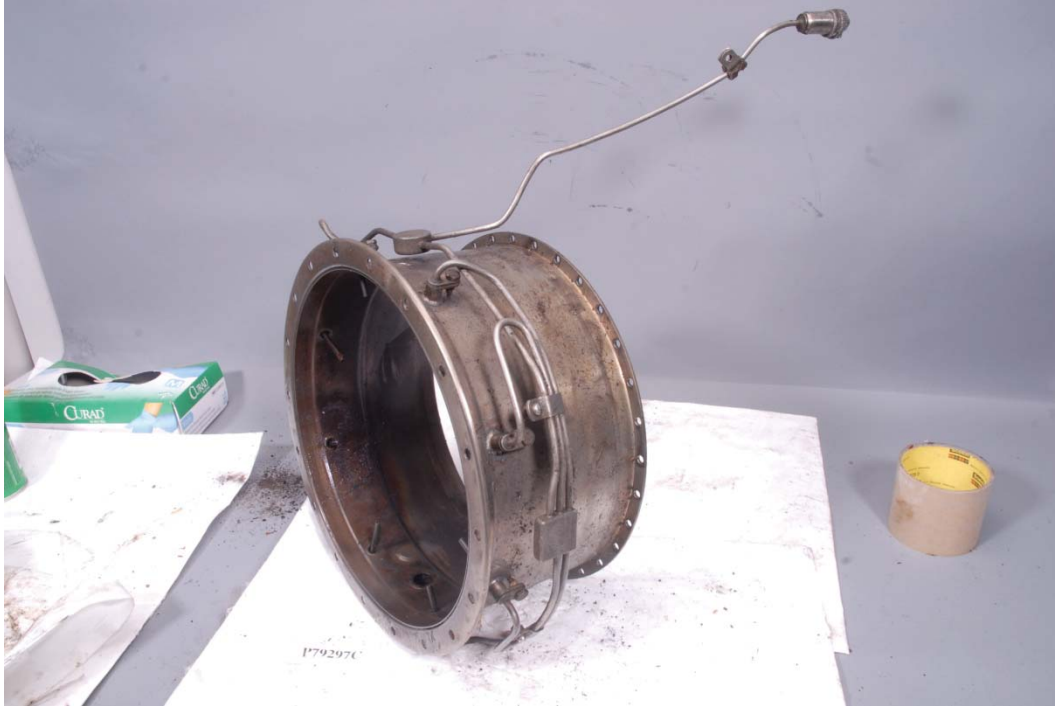
- (h) Rear Curvic Coupling:
- The rear curvic coupling appeared to be undamaged. (Figure 163 and Figure 164)
  - The rear curvic coupling teeth appeared to be undamaged.

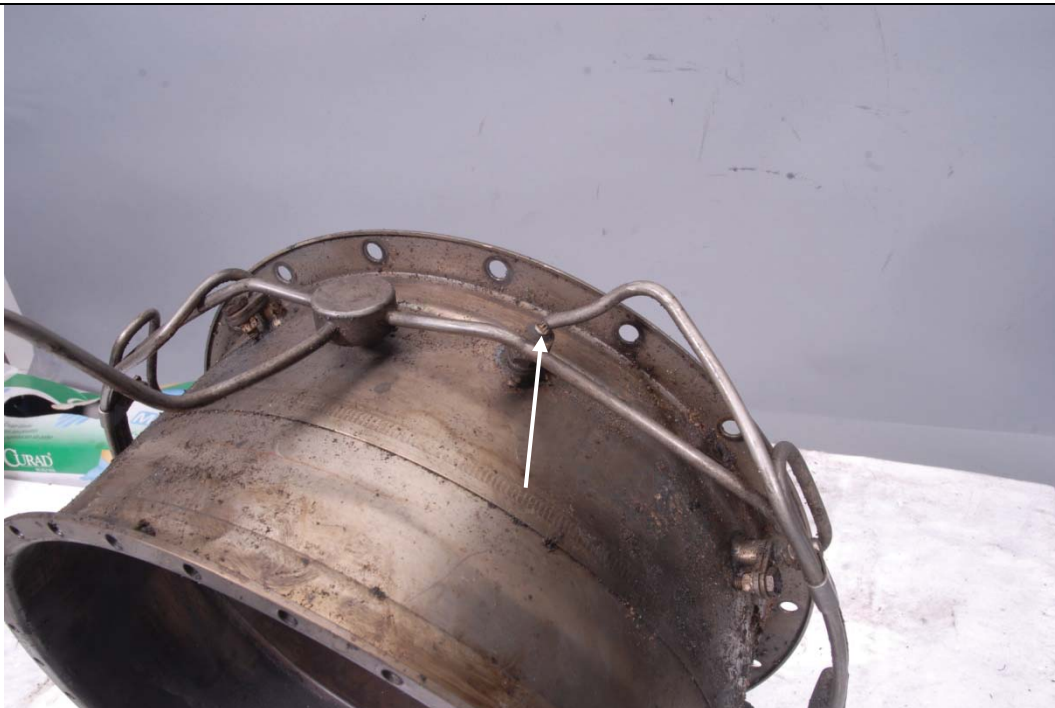
**Figure 165. P-79297C, Engine Exhaust Duct and Thermocouple Harness Assembly**

- (i) Engine Exhaust Duct: (Figure 165)
- The engine exhaust duct was intact and appeared to be undamaged.
- (j) Thermocouple Harness Assembly:
- The thermocouple harness was broken leading into one of the thermocouples at the 11 O'clock position, but otherwise appeared to be undamaged. (Figure 166)

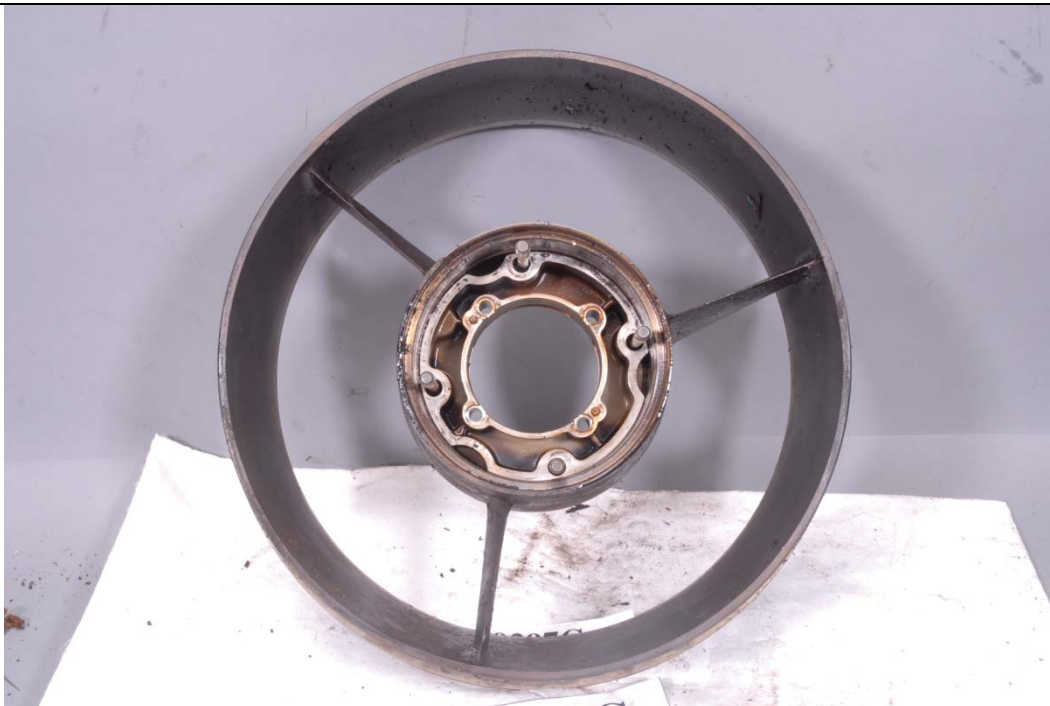
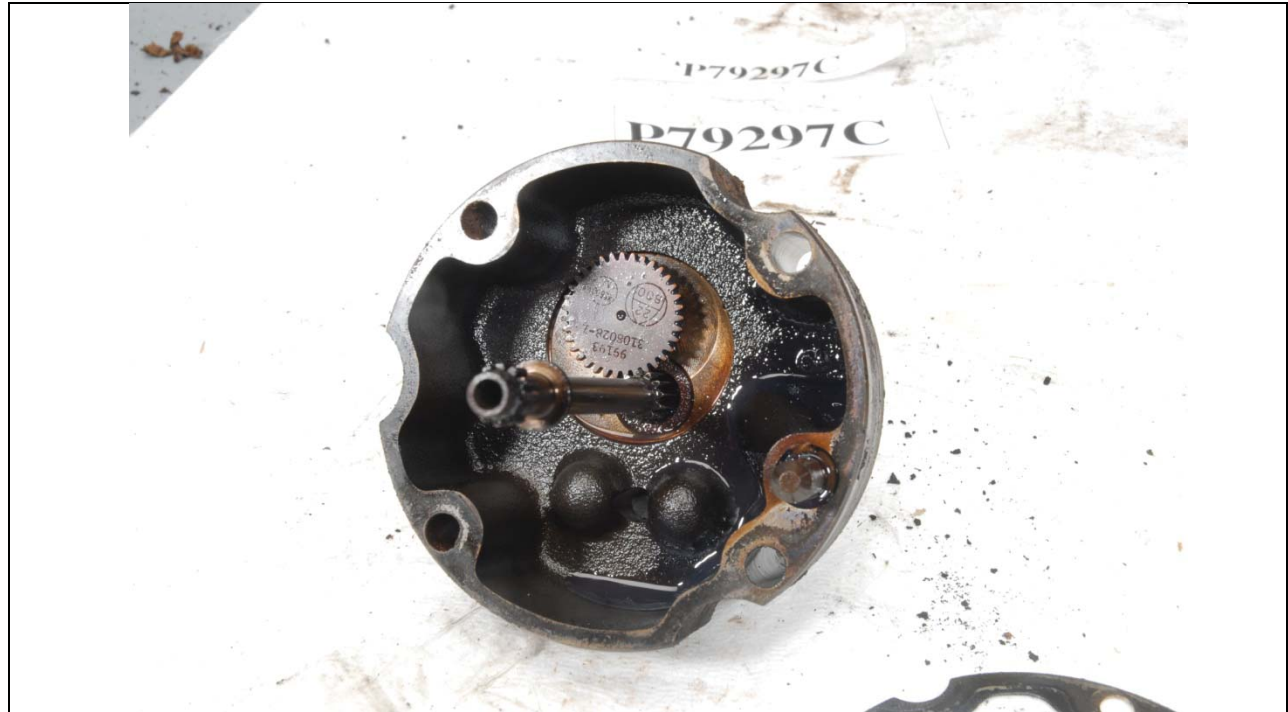
- The thermocouple harness assembly was not disassembled from the exhaust duct.
- (k) Turbine Bearing Support Housing: (Figure 167 and Figure 168)
- The turbine bearing support housing was intact.

- The turbine bearing support housing appeared to be undamaged.
- (l) Turbine Oil-Scavenge Pump and Drive Shaft: (Figure 169 and Figure 170)
- The turbine oil-scavenge pump and drive shaft appeared to be undamaged except for the noted corrosion on the external surfaces of the pump housing.
